A Look at the White House Kitchens

LYDIA BARKER TEDERICK

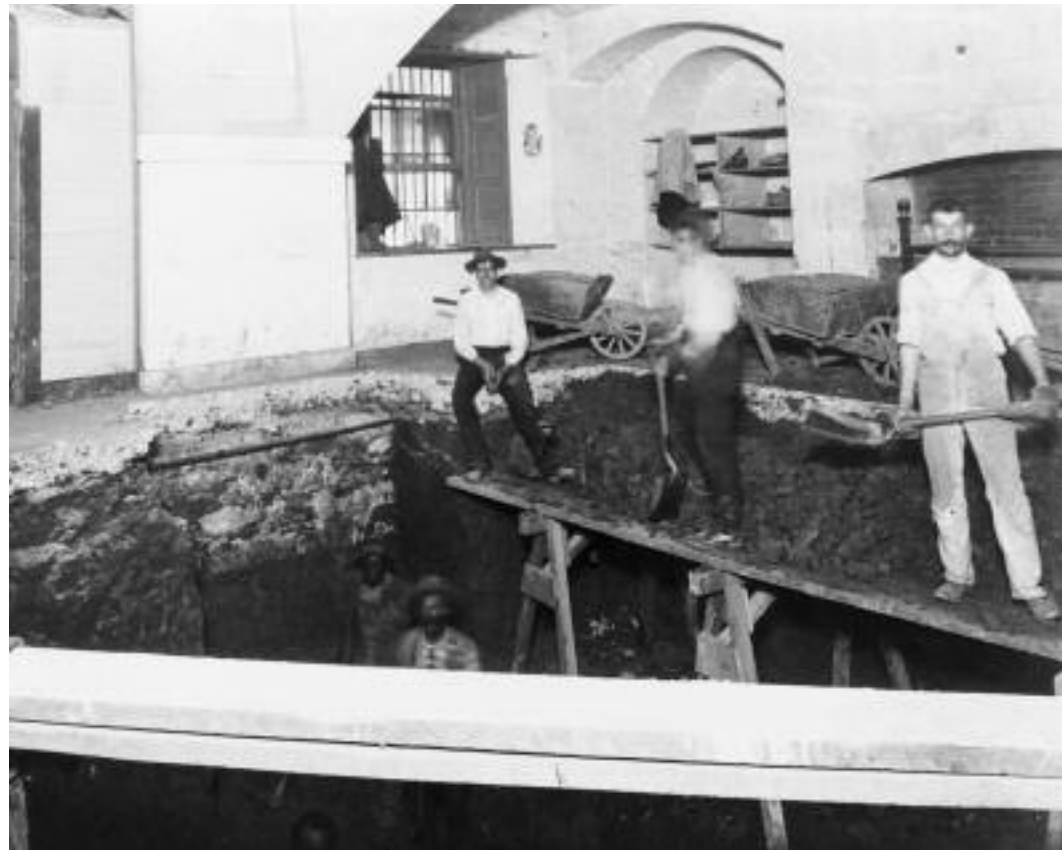
July 20, 1902.
 During the 1902 renovation, the space that had been the original kitchen, under the Entrance Hall, was excavated for a boiler pit. One of the early kitchen fireplaces is visible at right, still with fragments of an early turning spit.

The central room that had been the original kitchen, located under the Entrance Hall, was turned into a furnace room in 1902 and was used for that purpose until the Truman renovation, 1948–52. In 1935, the machinery was repositioned within the space to partition rooms for use as a staff dining room and a store pantry. During the Truman renovation, the furnace was placed underground and the old kitchen became the Broadcast Room. Since the Kennedy administration, the room has again been partitioned into smaller spaces, one of which is now occupied by the Office of the Curator.

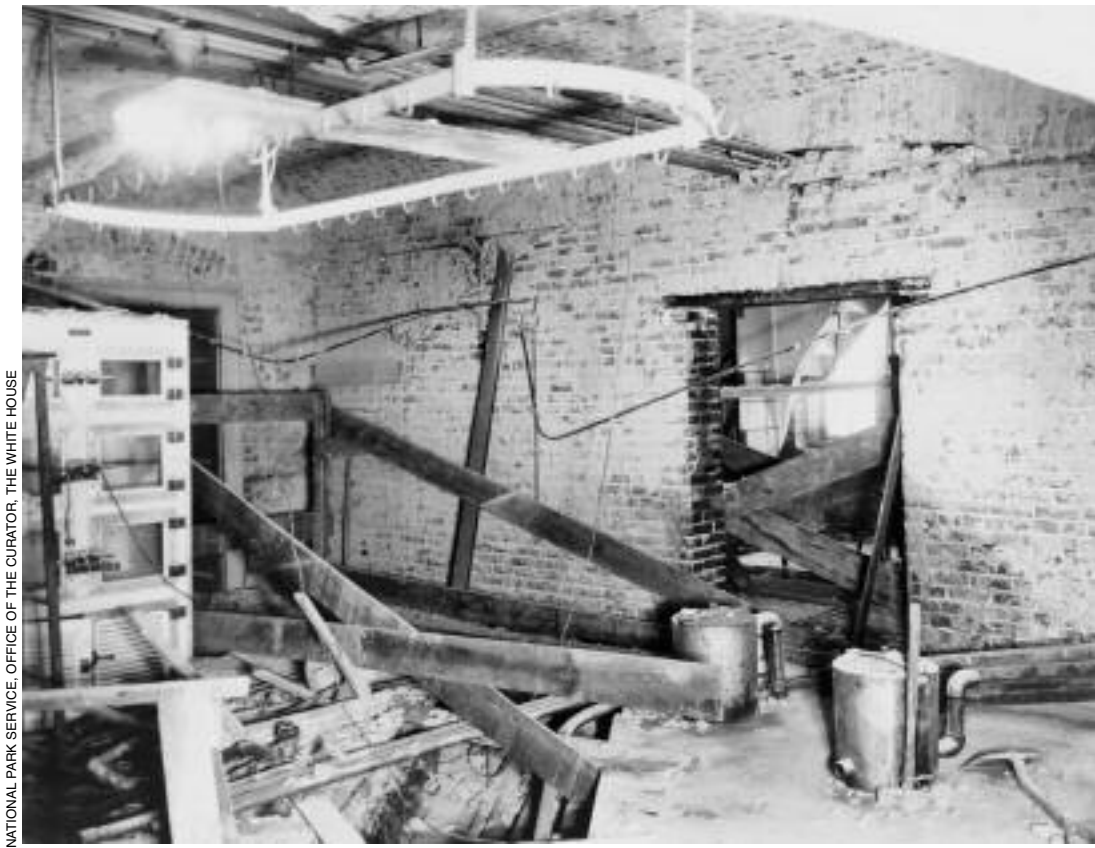
The southwest corner of the kitchen, photographed during construction. Through the doorway at right is a glimpse of the staircase added to the adjoining pantry in 1902. Note the pot rack still hanging overhead and in the walls, evidence of the old arching system that supported the house. Today this structural work is replaced by steel.

Demolition and construction took place during the summer and fall of 1935. To accommodate the number of new electric appliances, the entire electrical system was changed from direct current to alternating current.¹⁶ As with any major renovation, unforeseen problems arose. While changing the wiring, it was discovered that the plumbing had badly deteriorated. To replace all of the rusted pipes, the floors and walls were disturbed more than originally planned. Amazingly, with the room under excavation, wooden planks on the floor, and tun-

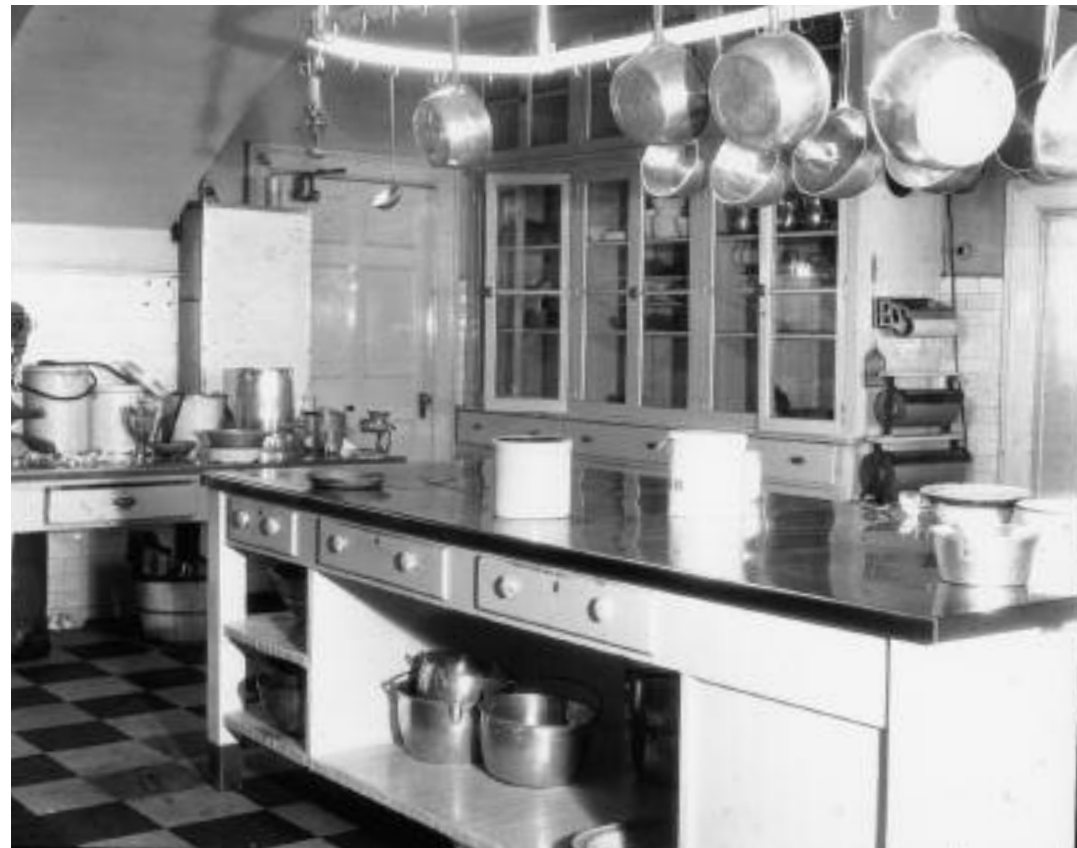
This photograph shows the southwest corner of the kitchen of 1902 as it appeared almost unchanged before remodeling. The door at left leads into the Ground Floor Corridor. The doorway at right opens into a pantry. This kitchen was not all of one design but was an accumulation of improvements beginning in 1902. The linoleum floor for example may not have been especially old.

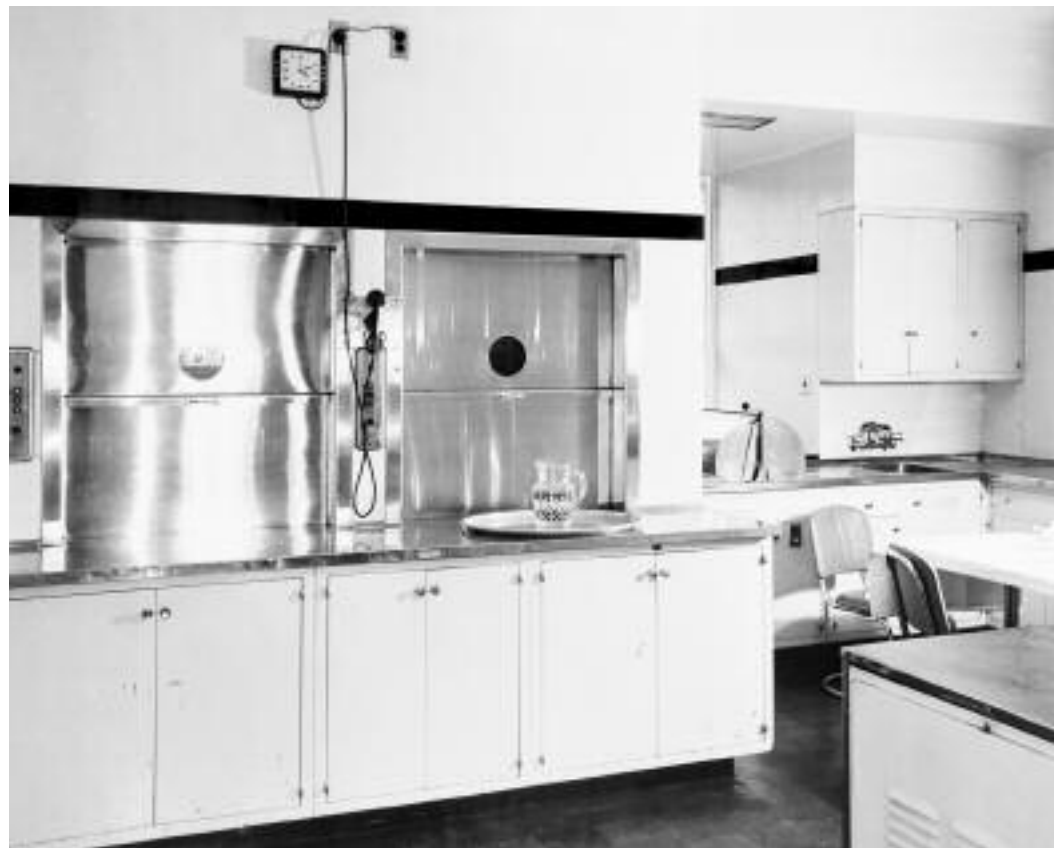
January 21, 1948.
Dumbwaiters in the
renovated kitchen of
1935 as they appeared
just before
demolition.

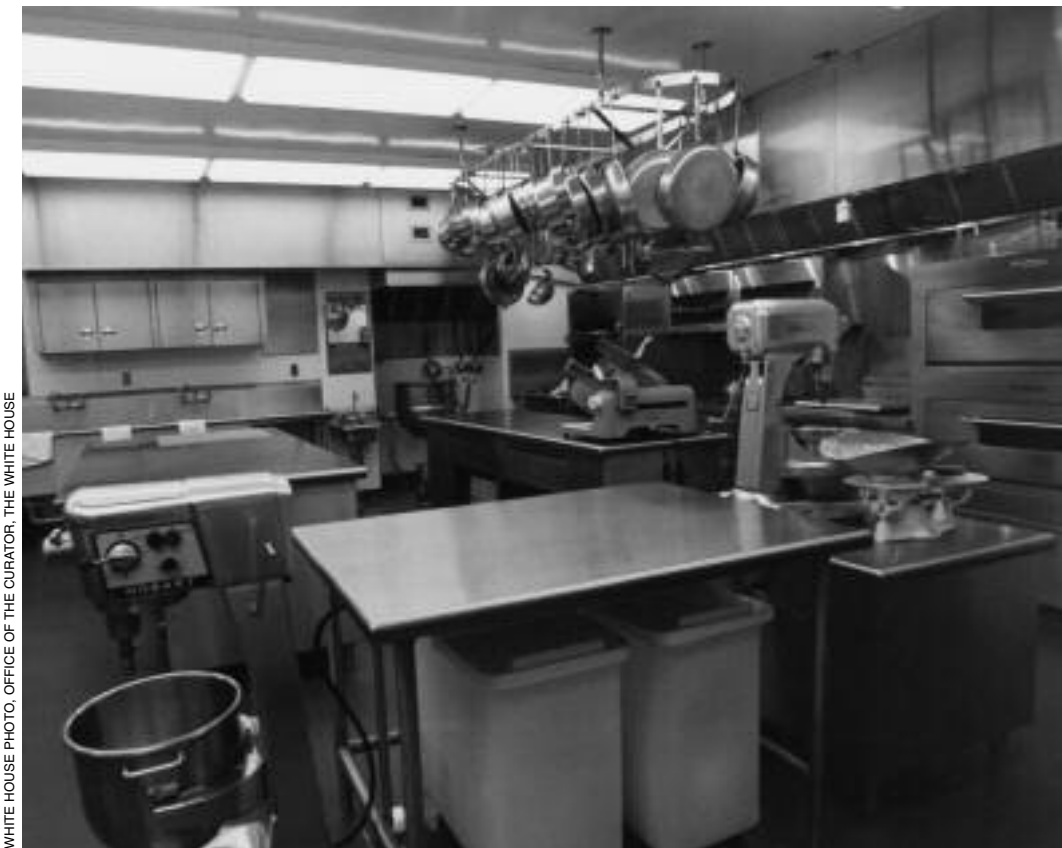
September 22, 1971.
This southeast view of the kitchen was taken after the project was completed. Much of the equipment installed nearly twenty years earlier during the Truman renovation, including two ranges and a food warmer from 1935, had become obsolete and was replaced. Work areas were rearranged to make better use of limited space.

The main kitchen was again renovated during August 1971, while President Richard M. Nixon and his family were away for a summer vacation. The project was undertaken primarily to make more efficient use of the limited available space and improve the ventilation and fire prevention systems. In addition, most of the equipment that dated to the Truman renovation, as well as two ranges and a food warmer from 1935, was obsolete and needed to be replaced.²¹ The renovation also eliminated foot traffic through the food preparation area by sacrificing a small part of the north end of the kitchen for a narrow hallway, created by the addition of a partial wall covered with tile, that led around the kitchen, into the pantry, and to the staff elevator. The White House Photo Office was on hand to photograph various stages of the work.

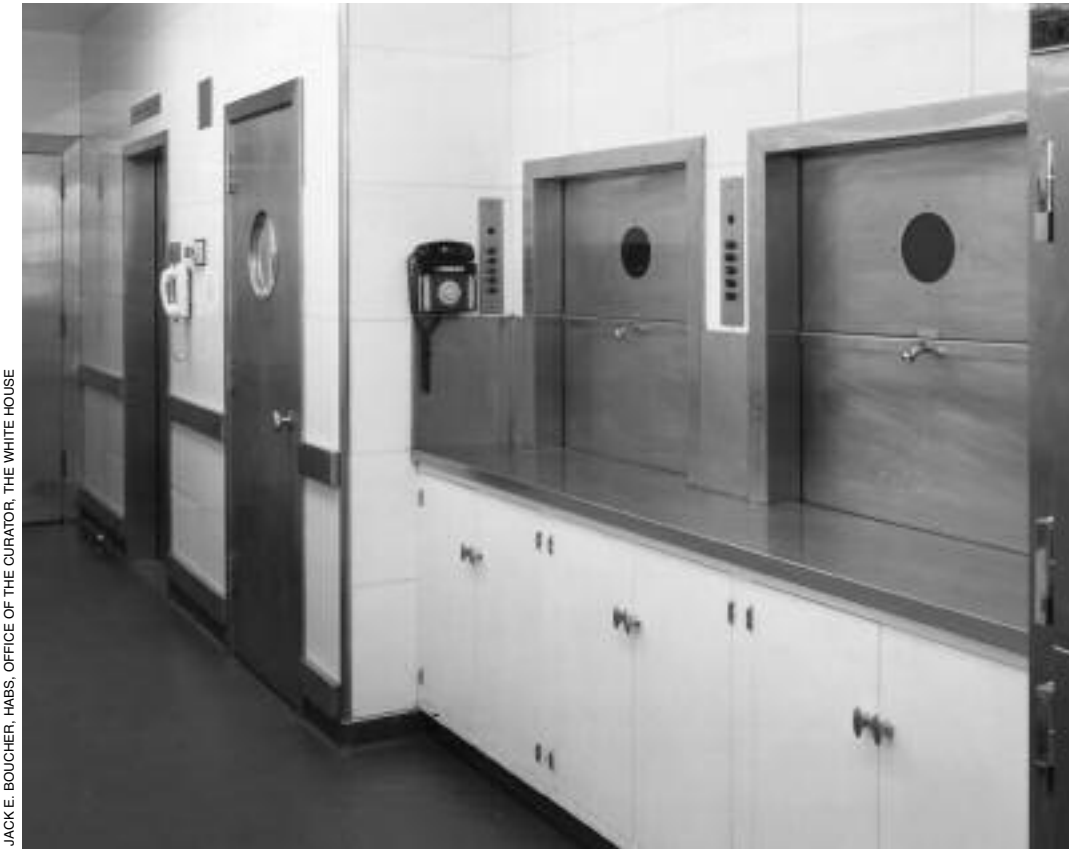
c. 1990–92.
During the Truman renovation, a spiral staircase and a staff elevator were placed next to the dumbwaiters in the pantry area to enable easier movement of food from the kitchen to the State Floor dining rooms. This arrangement remains to the present day.
